Service Bulletin

Nr. / no. **045-2020**

Qualitäts-Optimierung durch neue HD-Pumpen im CarWash-Bereich

Quality optimization through new HP pumps in the CarWash area.

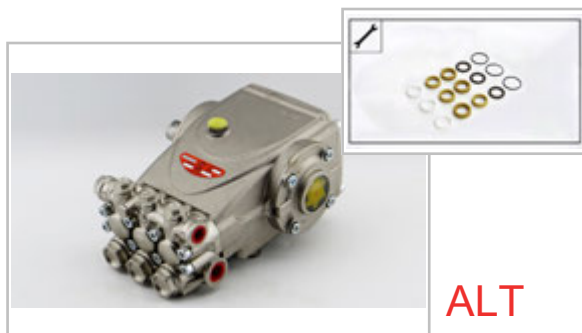
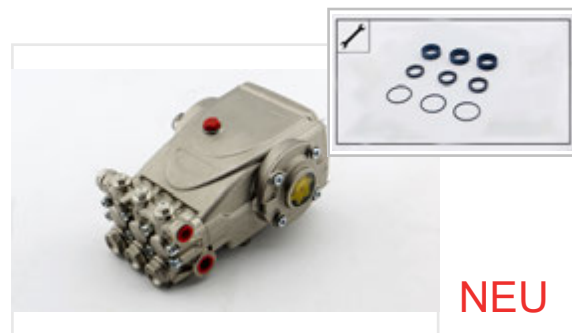
From now on the installation and sales for the previous HD pump C3W2015 SSL Ø20 (item no. 361315) with yellow tissue seal will be stopped

The successor is the HD pump E3B2015 SSL Ø20 (item no. 361424), with Teflon seals.

Repair kits 361332, 361333, 361334 and 361340 will be the same.

Repair kit 361338 will be replaced by 361455. Repair kit 361337 will be replaced by 361456.
